# Water Compliance Inspection Report

**National Pollutant Discharge Elimination System  
(NPDES)  
Compliance Evaluation Inspection Report**

**Kinross DeLamar Mine  
DeLamar, Idaho**

**Inspection date: September 8, 2016  
Report completion date: February 6, 2017**

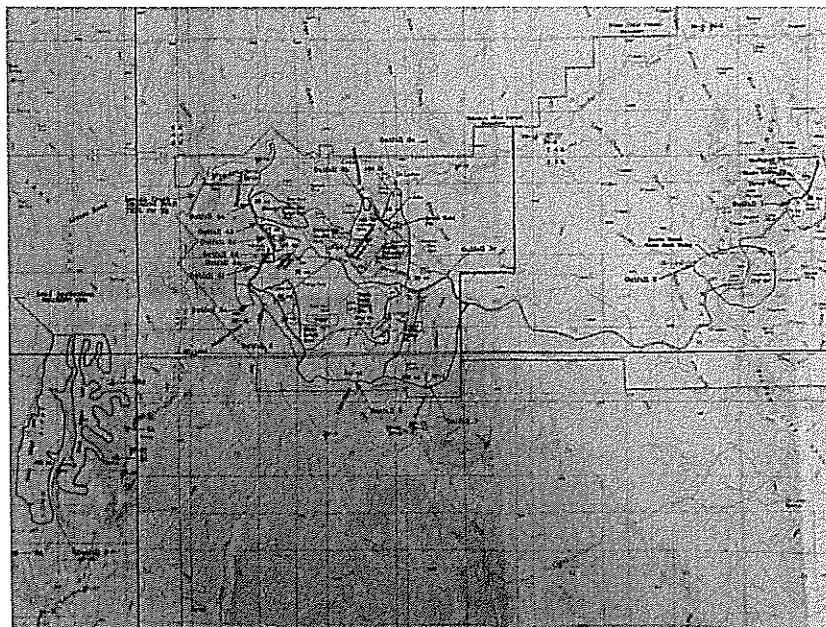
Photo No. 8 (P1000574 - cropped)

During rainfall and snowmelt events, stormwater runoff is discharged from the Kinross operations at a number of locations (no discharges were observed at the time of this inspection). The numeric designation would seem to suggest that there are eight different outfalls; in reality, there are many more. Three of the numeric designations apply to a general area rather than a specific outfall – both have more specific designations (e.g., 3a, 3b, and 3c) applicable to separate outfalls and/or gulches within the area (see Photos 8-10 for examples).

This map, borrowed from the 2014 inspection, identifies the location of the outfalls around the DeLamar site.

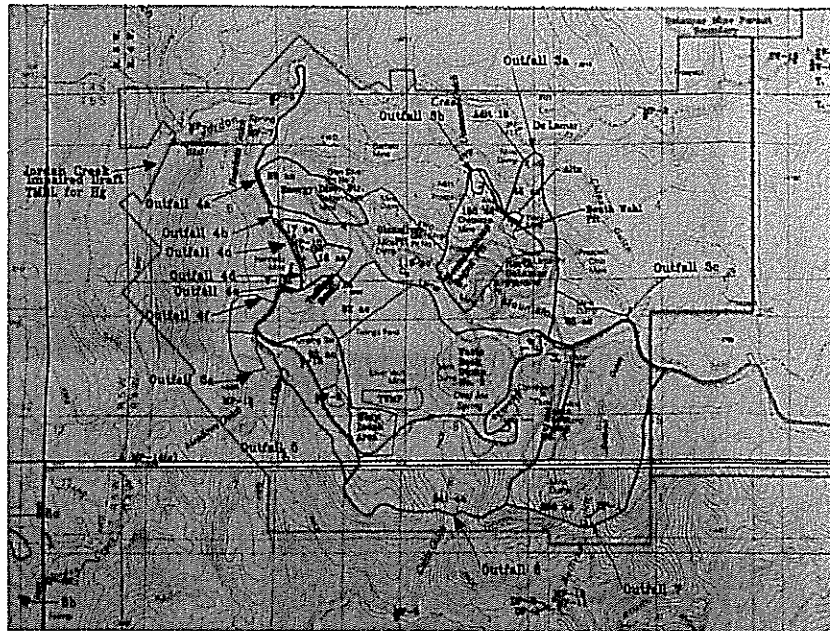
Photo No. 9 (P1000574 - cropped)

This map photo, borrowed and cropped from the 2014 inspection, identifies the location of the outfalls associated with the central portion of the mine site.

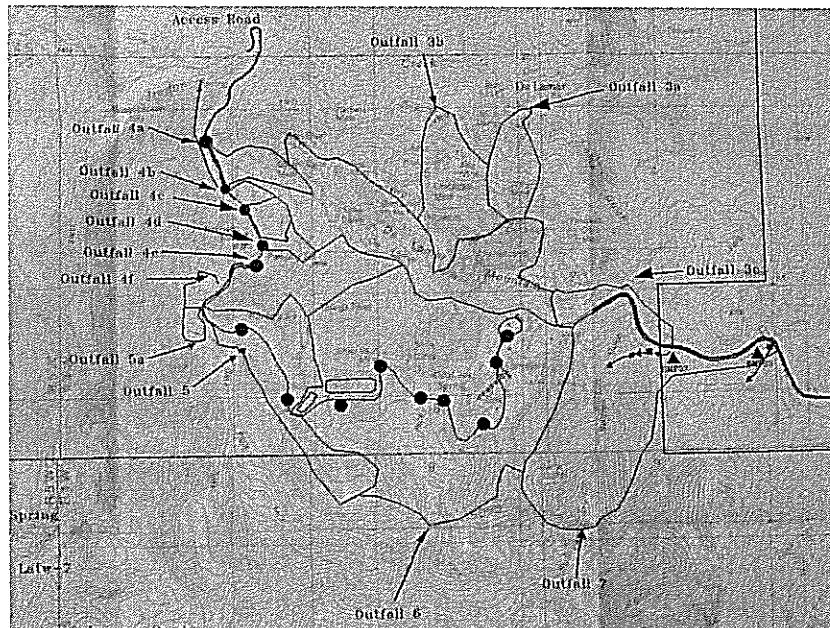
Photo No. 10 (P1020392 - cropped)

This map of the outfalls in the central portion of the mine is cropped from a map available at the time of the September 8, 2016 inspection.

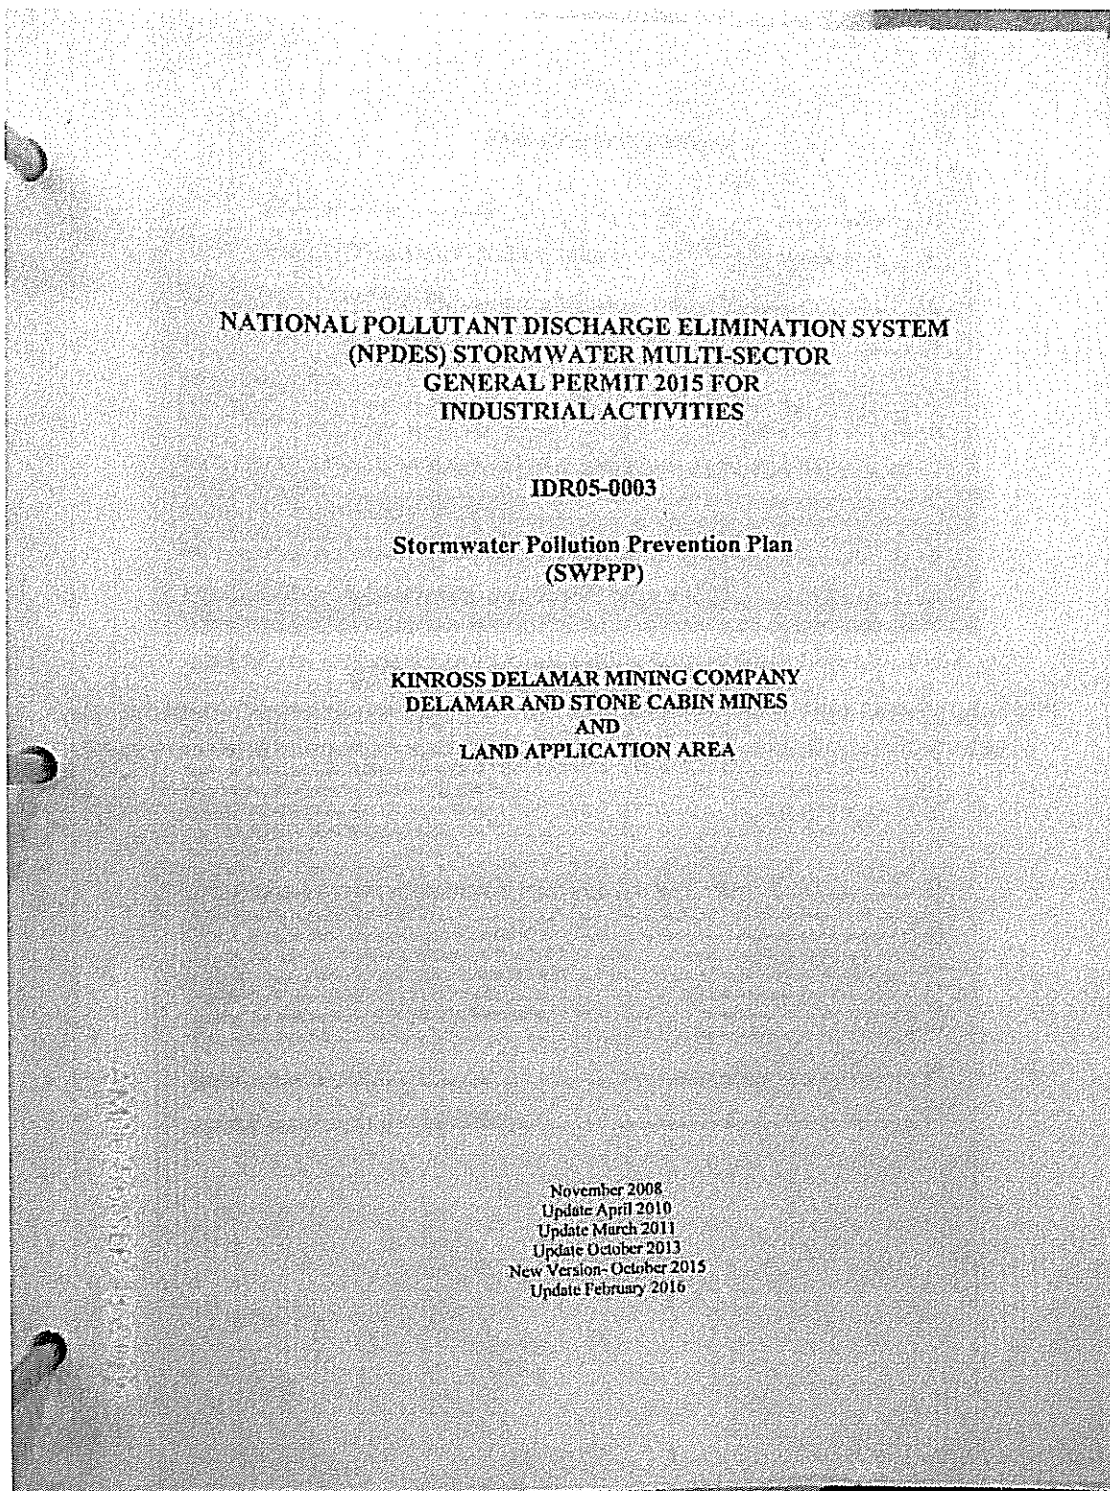
Photo No. 11 (P1020375)

The cover page of the SWPPP notes that a new version was created in October 2015; two months before submittal of the new Notice of Intent (as required).

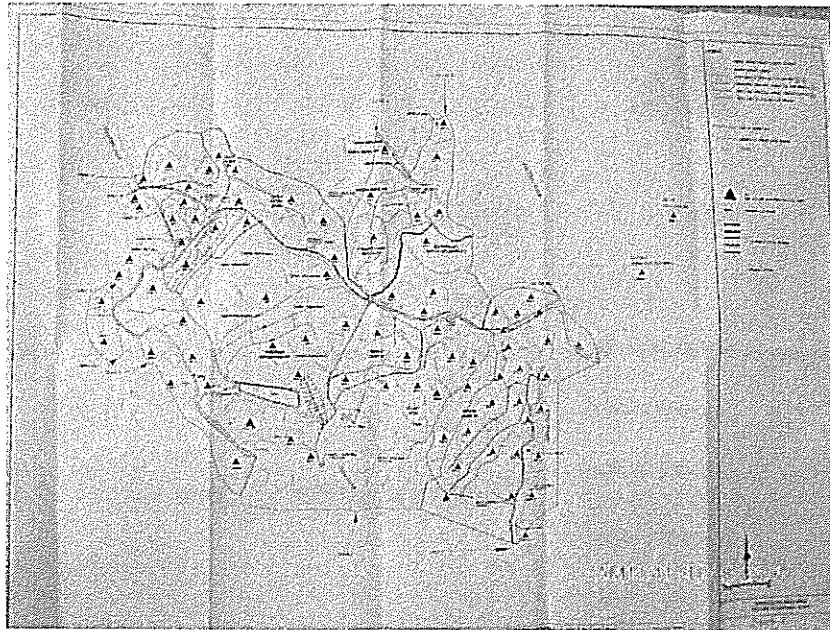
Photo No. 16 (P1020391)

This map provides general information about the BMPs installed at various locations around the site.

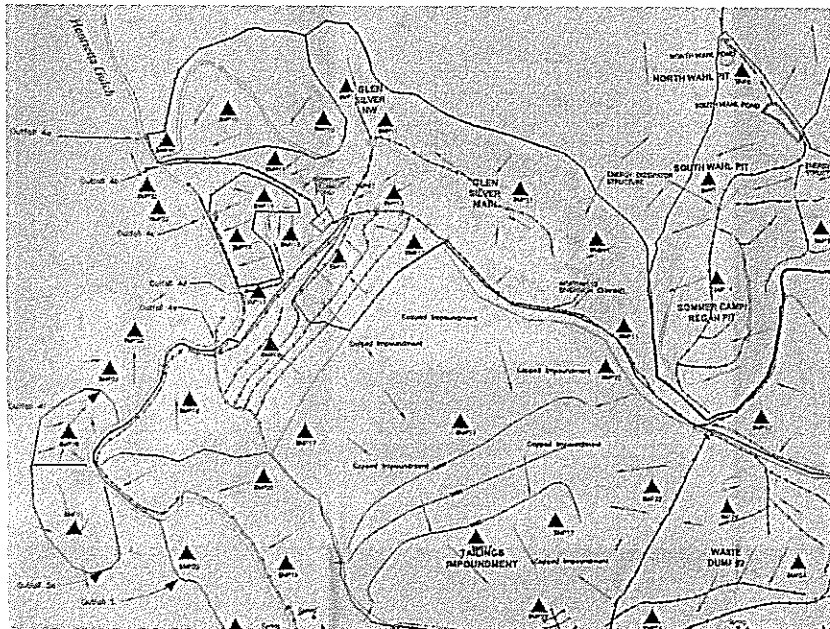
Photo No. 17 (P1020391 - cropped)

- The current map showing the location of best management practices (BMPs) used to control erosion and sedimentation are very general in nature; they use a standard symbol (a dark triangle) and a number to identify a general category of BMPs (see Photos 16-18). These maps are not detailed enough to show the exact location of the BMP placement, or (when appropriate) the number of BMPs within a particular category that have been installed. I recommended that Kinross create a more detailed map (or series of maps) that identify the specific location of BMPs as required by the MSGP.

This is a closer view of the BMP map. It provides general information about the BMPs that have been installed in a general area. It does not provide the type of detail that would identify the specific location for each BMP.

- The SWPPP (particularly the site map) must be updated routinely as conditions on the ground change. All updates can be recorded by hand.
- The SWPPP's site map needs greater detail to show specific locations where BMPs have been installed, added to, or removed.
- During the course of conducting routine facility inspections, when issues are noted that require some type of corrective action, you must note the specific date that corrective actions were implemented in order to verify compliance with the corrective action requirements in Part 4.3 of the 2015 MSGP.

- Keeping the site map current (challenging when conditions on the ground are changing almost day-to-day).
- Providing greater site map detail with respect to specific locations where BMPs are installed.
- Noting the specific day (not just month) when maintenance activities are performed.

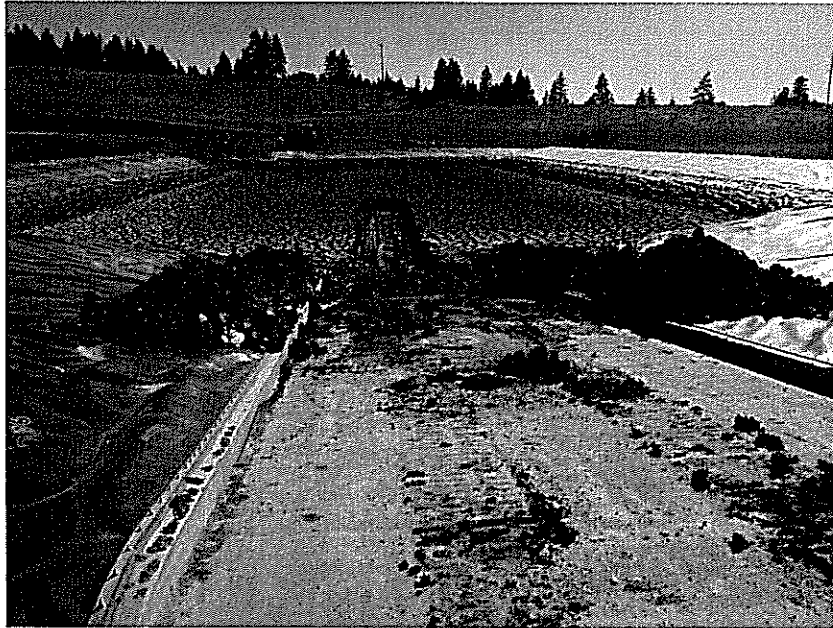
Photo No. 40 (P1020431)

Facing south – shortly before this inspection, composite samples of the sludge were collected for Toxicity Characteristic Leaching Procedure (TCLP) analysis. Sample results were not available at the time of this inspection.
